## Detailed Reserve Study

December 3, 2021

Reference: **Valley Forge Towers South Condominium Association  
Detailed Reserve Study  
Kipcon Project No. 14132-01**

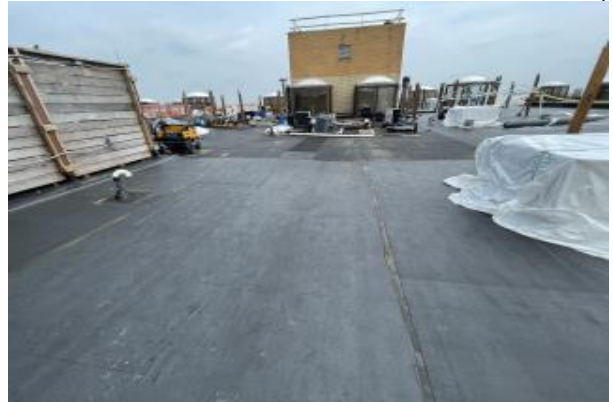
1. The unit cost shown represents the removal and replacement of the ethylene propylene diene monomer (EPDM) roofing membrane found on the main portion of the roof and the smaller section found on the elevator tower. The roofing project is an ongoing project and was being removed and replaced at the time of our site visit. The cost shown was provided by Mr. Jeff Rath.

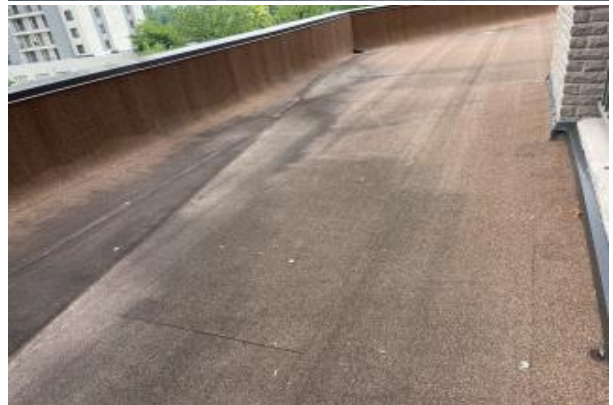
2. Modified bitumen roofing is installed at the lower level roof of the building. The unit cost shown represents the removal and replacement of the roofing. It also includes 6% for engineering and 15% for any additional work that is typically seen in these types of projects. The roofing was observed to be in poor condition and looks to be nearing the end of its useful life. The flashing should be inspected annually to ensure it is properly attached.

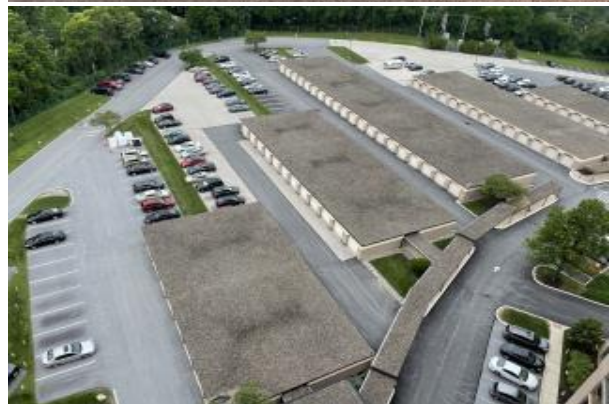
3. The unit cost shown represents the removal and replacement of the ballasted with stone EPDM roofing. At the time of our site visit, Kipcon was not able to walk these roofs ourselves, but no issues were reported regarding the roofing by the Association. According to the Association, the garage roofs were last replaced about 6 years ago.

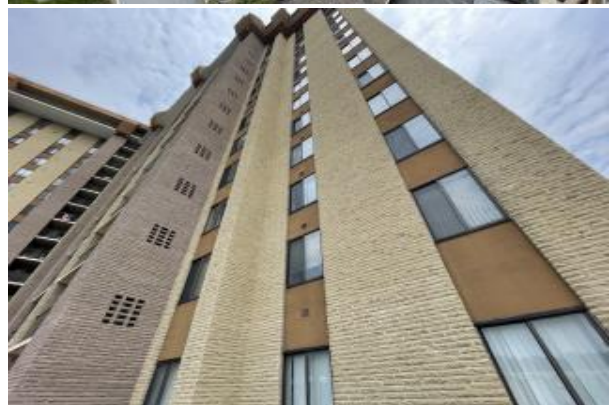
4. The unit cost shown represents the cost of repointing the brick facades found throughout the exterior of the building. Included in this quantity is the exterior facade of the main building and the brick found on the elevator tower. No obvious signs of mortar deterioration or brick disrepair were observed during our site visit. No issues regarding the brick facade were reported by the Association. A cursory inspection of the brick should be performed annually to determine if any areas of concern are evident.

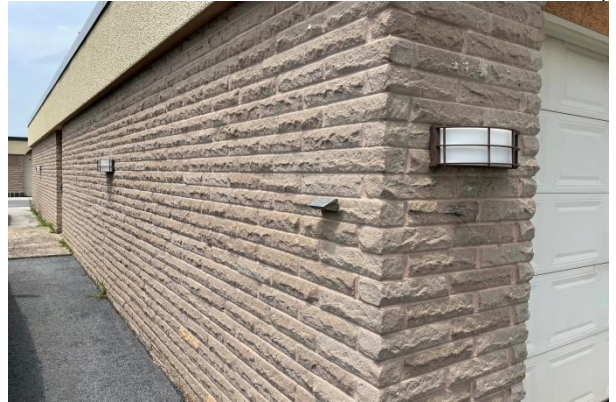
5. The unit cost shown represents the cost of repointing the brick facades found throughout the exterior of the three garage buildings. No obvious signs of mortar deterioration or brick disrepair were observed during our site visit. No issues regarding the brick facade were reported by the Association. A cursory inspection of the brick should be performed annually to determine if any areas of concern are evident.

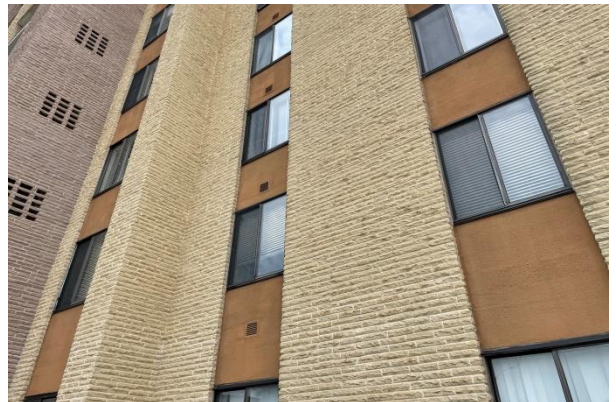
6. The unit cost shown represents the removal and replacement of the exposed aggregate facade found along the exterior of the building. According to the Association, the community has been suffering with some issues regarding this component. Aggregate has begun to break and fall off the facade. This poses both an aesthetic and safety problem, as the aggregate that falls off can possibly cause damage falling from such great heights. It is recommended that a more detailed structural review be performed regarding the exterior facade.

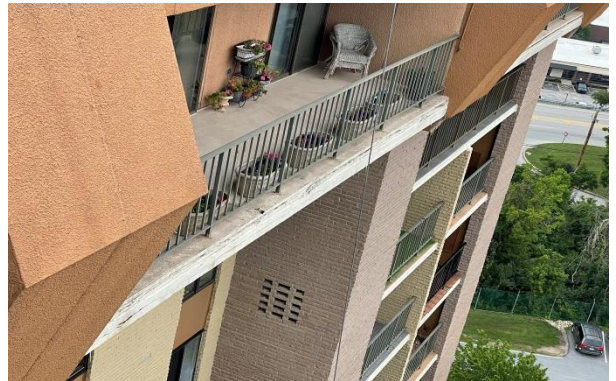
7. The cost shown represents a contingency amount for the balcony replacement work. The cost shown is based on a quote received by the Association from the Harmon Group. According to the Association, there are plans to repair and replace various concrete balconies. Our observations confirmed that the concrete balconies were in poor condition, suffering from cracking and spalling in some areas. This component should be monitored closely and addressed soon, as loose concrete can pose a major safety concern. It is recommended that a more detailed inspection of all the balconies is performed so a replacement schedule can be determined. See the supplementary section at the end of the report for more information.

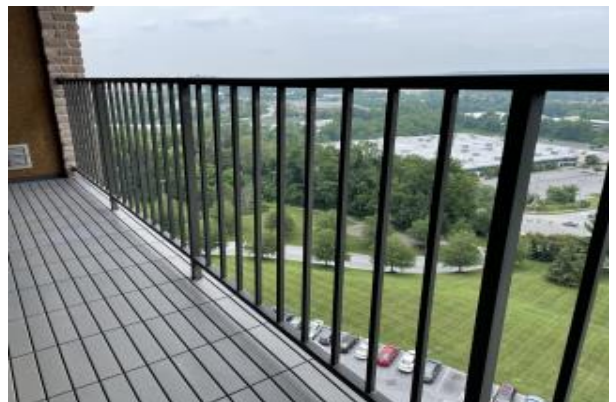
8. The unit cost shown represents the removal and replacement of the aluminum railing found on the concrete balconies. It was observed in the units visited (14X & 14Q) that the railing may have been a bit loose which can pose a safety concern. No signs of deterioration to the aluminum railing were observed among the balcony railings observed. The estimated remaining useful life shown represents removing and replacing the railings on an as-needed basis. The railings should be inspected annually to determine if any corrosion is evident. The estimated remaining useful life shown represents replacing the railing on an as needed basis.

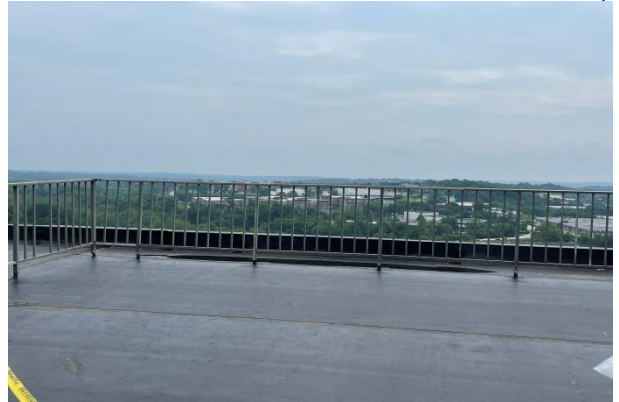
9. The unit cost shown represents the removal and replacement of the aluminum railing found at unit owner terraces at the roof of the building. At the time of our site visit, this was an ongoing project where the roof and unit owned terraces are being replaced. The quantity shown was taken from the drawings provided by the Association. The cost shown was provided by Mr. Jeff Rath. The railings should be inspected annually to determine if any corrosion is evident.

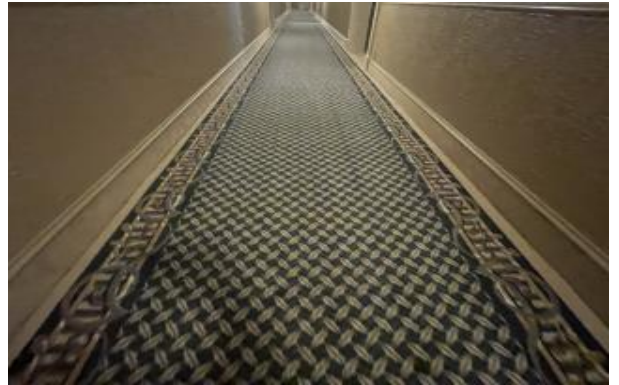
10. The unit cost shown represents the removal and replacement of the carpeting found throughout the building. The carpeting can mainly be found on floors 2nd through 15th, as well as some sections on the main 1st floor. According to the Association, the carpeting was last replaced 5 years ago. The carpeting was observed to be in fair condition, with no major or consistent signs of deterioration observed.

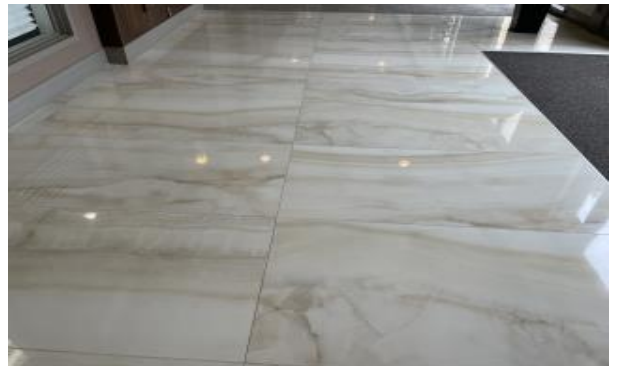
11. The unit cost shown represents the removal and replacement of the porcelain tile found in the 1st Floor of the building. The tile flooring was observed to be in good condition overall with no signs of disrepair or deterioration. The tile should be cleaned regularly.

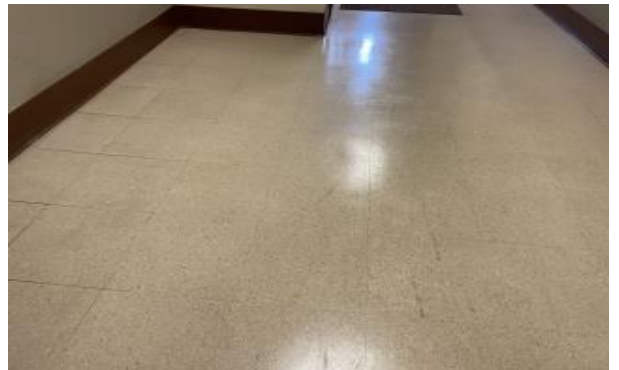
12. The unit cost shown represents the removal and replacement of the vinyl tile found near the stairwell entrances on the 1st Floor of the building as well as at the trash rooms on each floor. The tile flooring was observed to be in fair condition, with minor signs of scratches and scuffing.

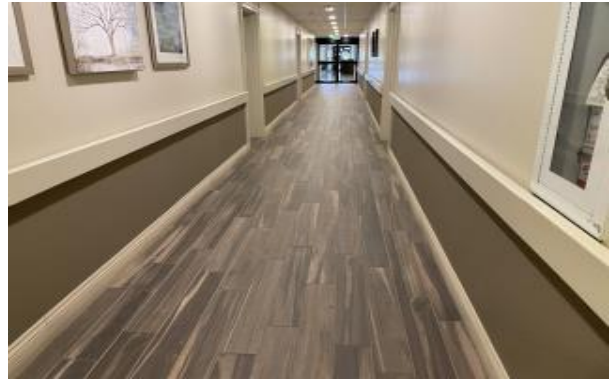
13. The unit cost shown represents the removal and replacement of the tile flooring found on the hallways of the 1st Floor of the building. The flooring was observed to be in good condition overall with no signs of deterioration or disrepair to the tile flooring.

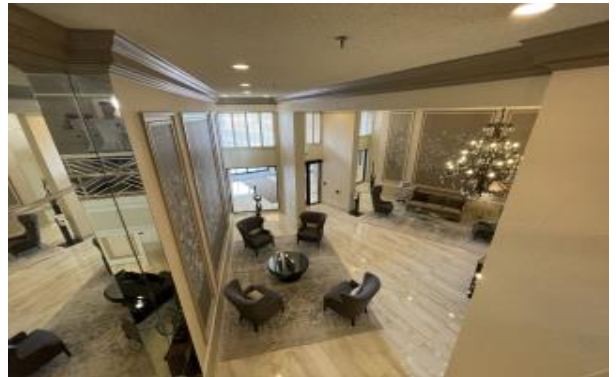
14. The lump sum cost shown represents the removal and replacement of the interior furnishings found throughout the building. This component includes the furnishings found in the main lobby area, office areas, and 1st floor hallways. The furnishings were observed to be in fair to good condition with no signs of deterioration observed. The estimated remaining useful life shown represents replacing the furnishings on an as-needed basis.

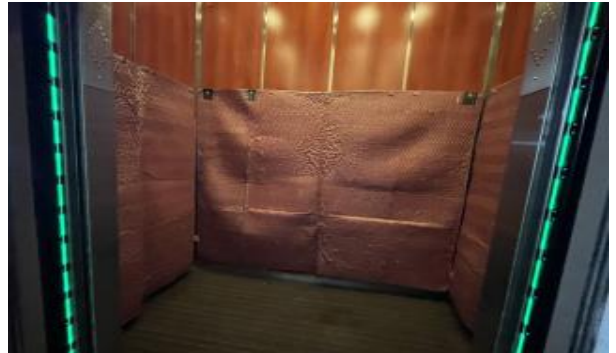
15. The unit cost shown represents the cost for the interior refurbishment of the elevator cabs found within the building. Included in this component are the two passenger elevators, as well as the service elevator. This component includes the flooring, walls, and lighting. The estimated remaining useful life shown is based on refurbishment being done on an as needed basis.

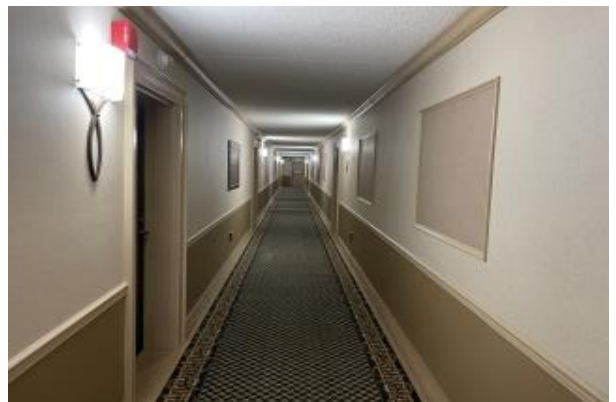
16. Wallpaper is installed throughout the common hallways of the building. The lump sum cost shown represents the removal and replacement of the wallpaper. The wallpaper was observed to be in fair to good condition overall.

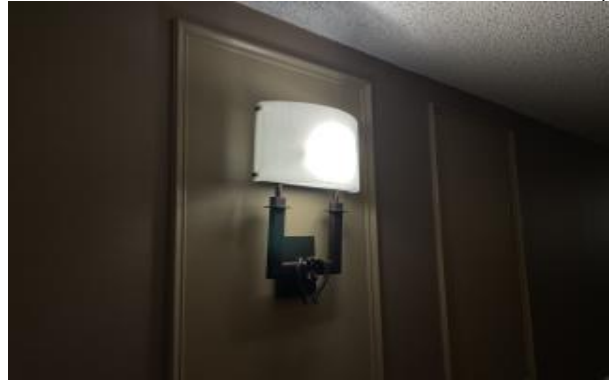
17. The lump sum cost shown represents the removal and replacement of the interior lighting found within the building. Included in this component are the sconce lighting, recessed lighting, chandelier lighting, ceiling mounted lighting, and fluorescent tube lighting. The lighting fixtures were observed to be in fair condition overall. No problems were reported at time of observations. The estimated remaining useful life shown represents replacing the light fixtures on an as needed basis.

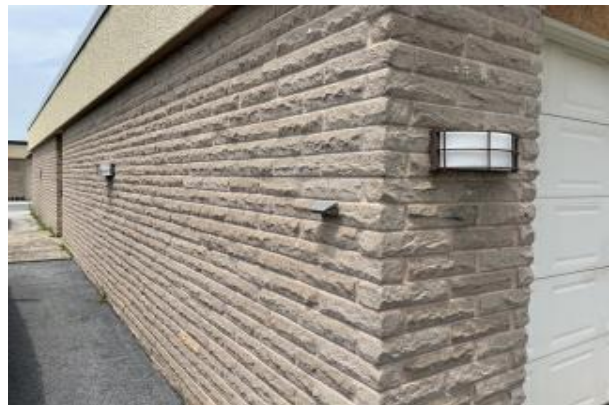
18. The lump sum cost shown represents the removal and replacement of the exterior lighting found throughout the Building and garages. Included in this component are the wall mounted lighting found on the garage bays, recessed lighting found near the three entrances to the main building and ceiling mounted lighting found on the shade structures near the garage bays. The lighting fixtures were observed to be in fair and operable condition. The lighting should be checked periodically to determine which bulbs have burned out.

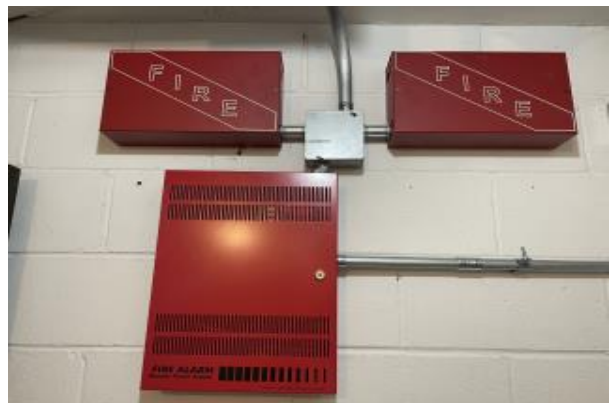
19. The lump sum cost shown represents the removal and replacement of the fire safety equipment found throughout the building. Included in this component are the fire extinguishers, pull stations, detectors, horn/strobes, and the fire panel systems found on each floor. According to the Association, the fire panels on each were replaced about two years ago. The components were observed to be in fair and operable condition. No problems reported at the time of observations. The estimated remaining useful life shown is based on replacements being done on an as needed basis. The panel and system should be tested annually to ensure they are working properly.

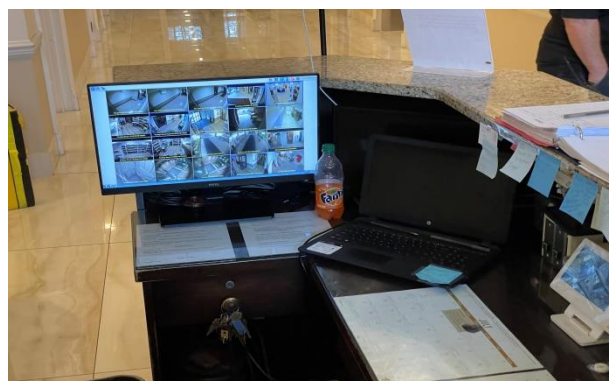
20. The lump sum cost shown represents the removal and replacement of the security camera system that services the building. According to the Association, there are 16 cameras in the security system. The system and cameras were observed to be in fair and operable condition with no signs of disrepair.

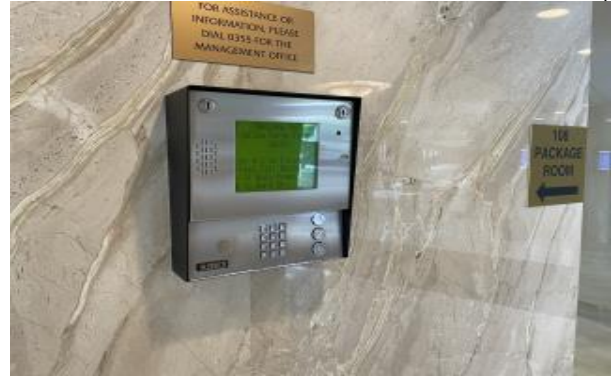
21. The lump sum cost shown represents the removal and replacement of the intercom system that services the building. The master station was observed to be in fair and operable condition. The lump sum cost shown only includes the master station on the main floor of the building.

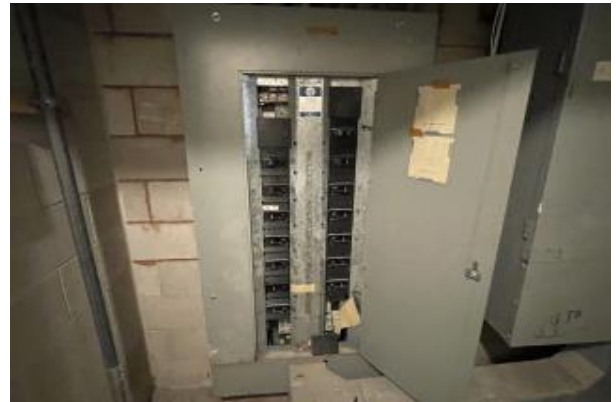
22. The unit cost shown represents the removal and replacement of the breakers found in the breaker closets on each floor of the building. According to the Association, there are 253 (one per unit) 100 AMP breakers, as well as one 60 AMP breaker per each floor hallway. It was brought to our attention that breakers would require replacement within the next few years. According to the Association, each breaker costs +/- \$1900. An additional 30% has been added for demolition and installation of the new breakers. The breakers should be exercised annually and the cabinets should be kept clear of any debris.

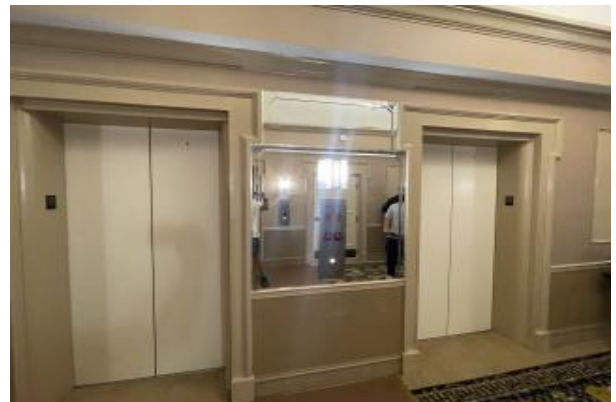
23. The unit costs shown represent the removal and replacement of the 2 passenger and 1 service elevator found within the building. The elevator mechanical equipment, as well as the cabins themselves were observed to be in fair and operable condition with no obvious signs of deterioration or disrepair observed. No issues regarding the elevator or elevator equipment were reported by the Association. The emergency phone system should be tested quarterly. The elevators should be inspected comprehensively each year by the elevator maintenance contractor.

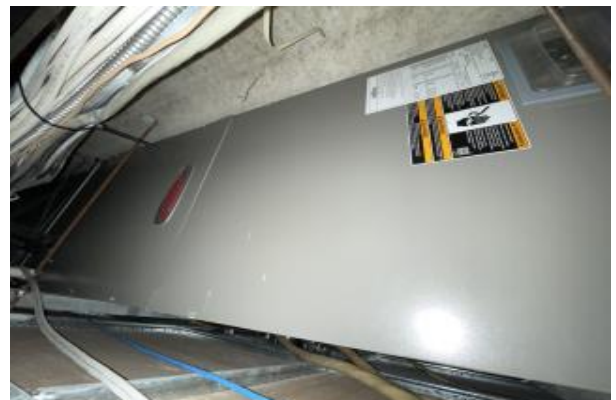
24. The unit cost shown represents the removal and replacement of the heat pumps (indoor & outdoor units) that serves the 1st Floor, including hallways, manager's office, and lobby only. No problems were reported at the time of observations. The Association may choose to replace the existing heat pumps with higher efficient equipment, which will help to save on long term energy costs. The air filters should be inspected monthly to determine if they require replacement. Any condensate drain lines should be inspected regularly to ensure no leaks or clogs are evident. The motors should be inspected twice annually to ensure proper operation.

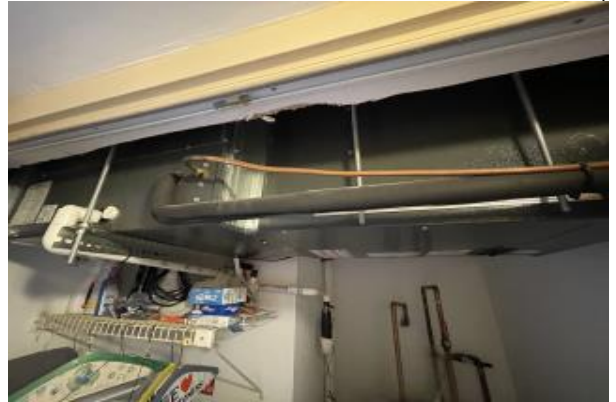
25. The unit cost shown represents the removal and replacement of the heat pumps found in the individual home owner units. According to the Association, there are a total of 253 heat pumps found throughout the building. Also according to the Association, about 25 heat pumps are replaced per year. The Association may choose to replace the existing heat pumps with higher efficient equipment, which will help to save on long term energy costs. The air filters should be inspected monthly to determine if they require replacement. Any condensate drain lines should be inspected regularly to ensure no leaks or clogs are evident. The motors should be inspected twice annually to ensure proper operation.

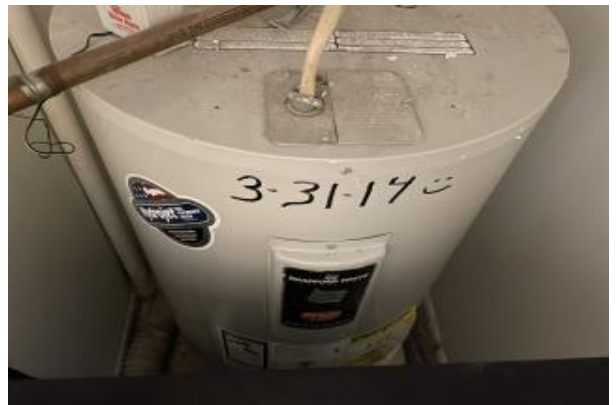
26. The unit cost shown represents the removal and replacement of the water heaters found throughout the building. According to the Association, there are a total of 283 50-gallon water heaters which follow a 10 year cycle of replacement. Also according to the Association, about 25 water heater units are replaced per year. The water heaters observed at the time of our site visit were observed to be in fair condition. The Association may choose to replace the water heaters with more efficient models which may potentially lead to lower energy costs. Water heaters should be inspected quarterly to ensure no leaks are evident, valves are operable, and hot water temperature is acceptable.

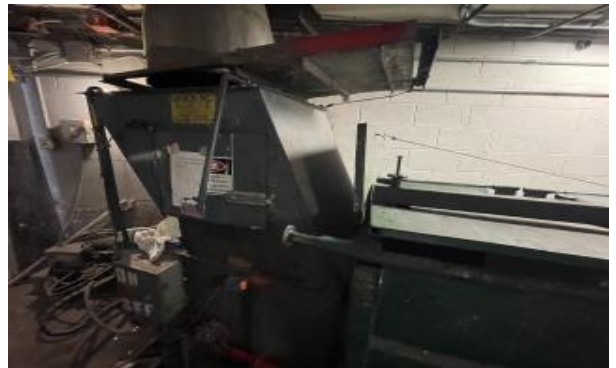
27. The unit cost shown represents the removal and replacement of the trash compactor found in the lower level of the building. According to the Association and through our own visual observations, it was observed the trash compactor was in poor condition. The fluid level and hydraulic hoses should be inspected regularly to ensure no leaks are present. The hydraulic oil should be drained and replaced annually and the filters should also be replaced annually.

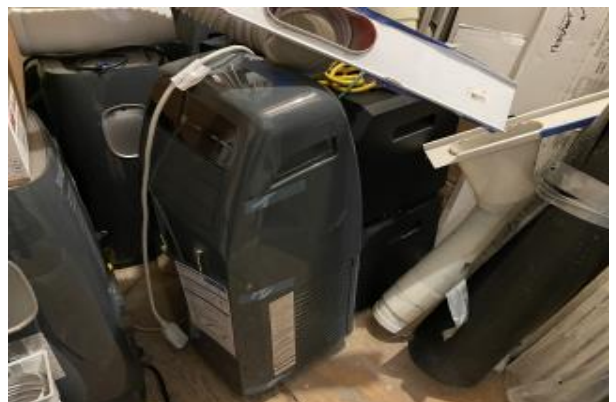
28. The lump sum cost shown represents a contingency fund for the removal and replacement of the portable A/C units found within the building. At the time of our site visit, several of these units were put away in a storage closet on the 2nd Floor of the building. The estimated remaining useful life shown is based on repairs and replacements being done on an as needed basis.

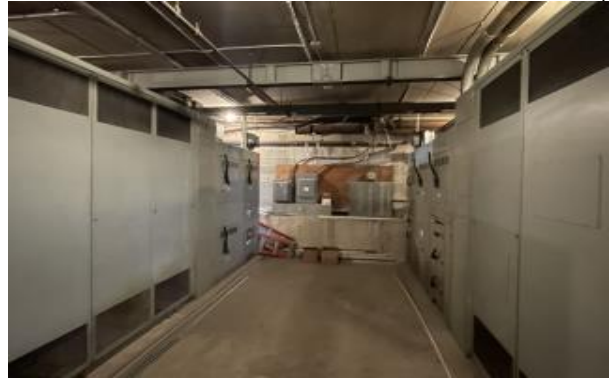
29. The unit costs shown represent the removal and replacement of the transformers found in the lower level of the building. The transformers were observed to be in fair and operable condition. No issues regarding this component were reported by the Association. The estimated remaining useful life shown is based on repairs and replacements being done on an as needed basis.

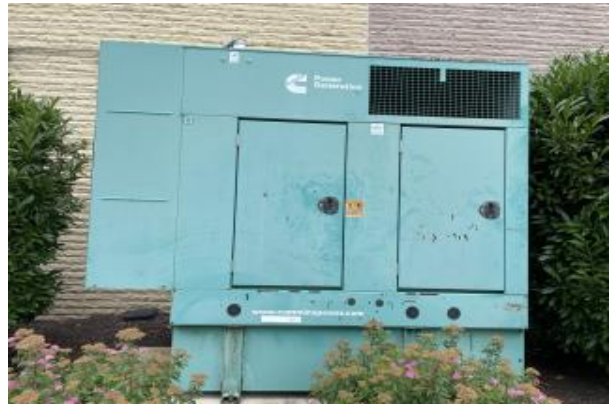
30. The unit cost shown represents the removal and replacement of the diesel generator found around the exterior of the building. According to the Association, the component is a 50HP generator which was last replaced approximately 10 years ago. The generator was observed to be in fair and operable condition with no signs of disrepair observed or reported by the Association. The generator should be exercised at least monthly. The fuel/oil levels and battery charge should also be checked monthly. All filters should be replaced annually as well as coolant levels checked.

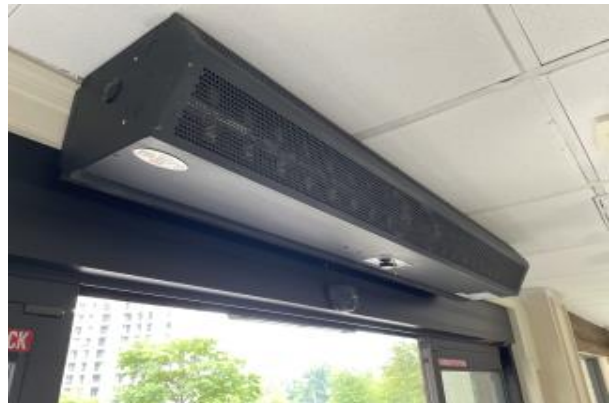
31. The unit cost shown represents the removal and replacement of the entry air curtain found near the main entrance of the building. The air curtain was observed to be in fair and operable condition with no signs of disrepair. No issues were reported regarding this component by the Association.

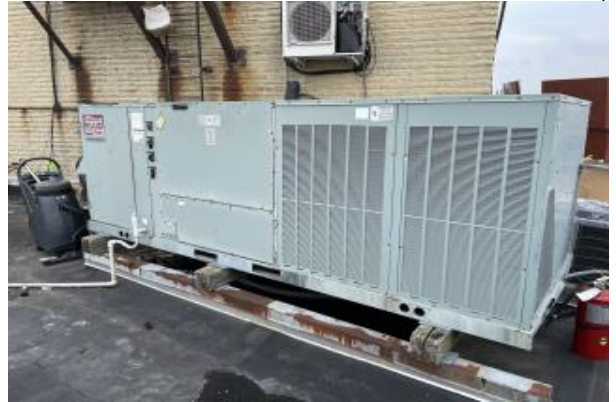
33. The cost shown represents the removal and replacement of the rooftop mechanical unit and includes a percentage for mobilization. The rooftop unit was observed to be in fair and operable condition with no signs of disrepair. No issues regarding this component were reported by the Association. The Association may choose to replace the equipment with a more efficient unit in order to potentially lower the energy costs. The air filters should be inspected monthly to determine if they require replacement. Any condensate drain lines should be inspected regularly to ensure no leaks or clogs are evident. The motors should be inspected twice annually to ensure proper operation.

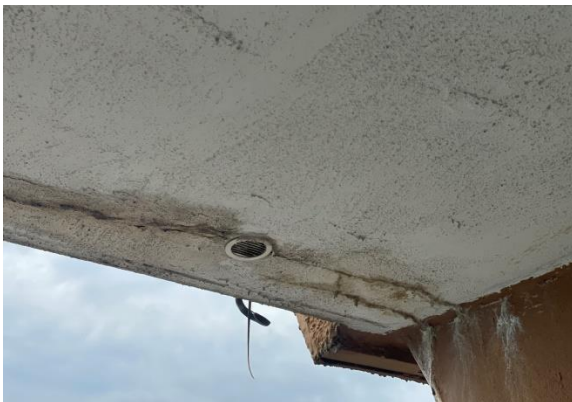
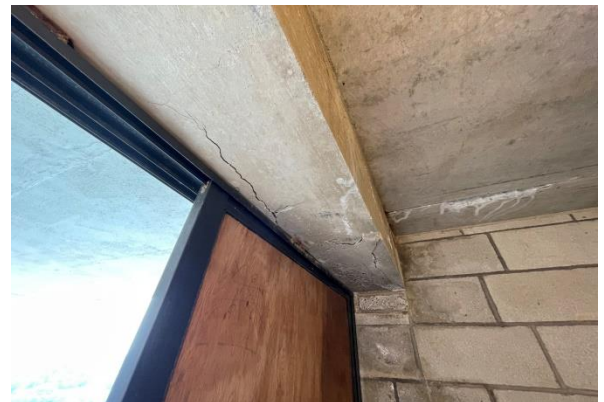
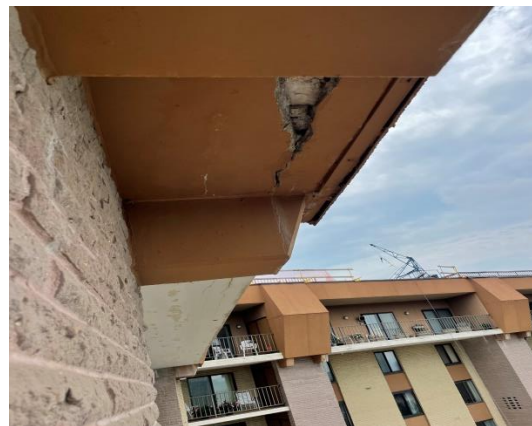
As part of our evaluation, the Building's Maintenance personal provided us access to units 14Q & 14X to observe the current problems. We have noted and confirmed at our site visit the existence problems at the balconies' slabs/planks and cantilever beams. Efflorescence was also observed. Efflorescence is a chalky white salt residue that occurs as moisture migrates through the surface of a material in which cement is a part of the composition. While efflorescence itself is not dangerous it is indicative of moisture which can cause damage to the building structure. These conditions are shown in the photos below. It is recommended that a more detailed evaluation of these conditions be performed.
